# Science Flight Report Operation IceBridge Antarctica 2010

Flight: F07 Mission: LVIS86c

## Flight Report Summary

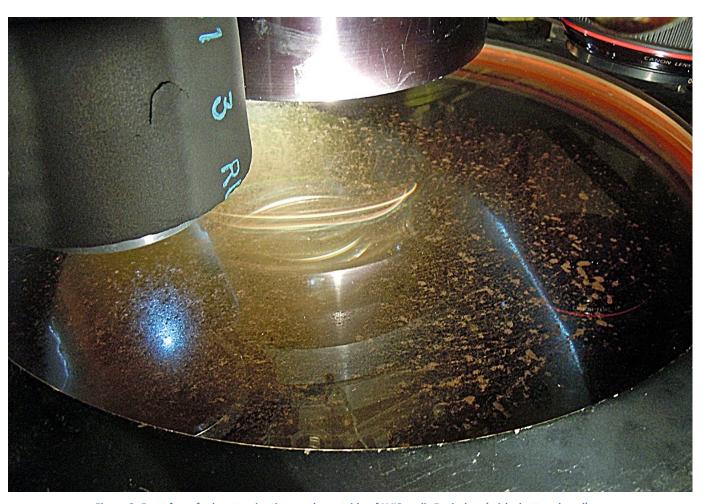
Figure 2: Frost from fuel contamination on the outside of LVIS nadir 5 window (with shutter closed) during today's mission before we reached the survey line. Photo: M. Studinger

Before the beginning of the arch the window of the LVIS laser began again building up frost on the outside similar to the flight on November 4, 2010 (Fig.2). The frost built up started around the same time after takeoff on both flights. The post-flight analysis on November 4, 2010 indicated that the nadir 5 window obstruction ended up being caused by jet fuel contamination. The source of the fuel contamination was believed to be fuel that had collected in the left hand wheel well area and then streamed aft to the nadir 5 window. The fuel in the wheel well area is minor seepage from the left hand forward auxiliary fuel tank. This occurs only when the aircraft is fueled up to approximately 160,000 lbs

for the long flights and then the aircraft sits for any substantial time. For the flight on November 4 the aircraft was fueled on October 30, 2010 and then flights were cancelled each day until we ended up flying on November 4, 2010. In order to prevent the window from being obscured again we implemented several changes in procedures. After each mission the aircraft is fueled less the forward aux tanks and then on the morning of flight we fuel the forward aux tanks. In addition to this we keep the LVIS shutter closed until we reach altitude and are exposed to temperatures below the freezing point of jet fuel. The source area was cleaned after the November 4 flight and we have not had any issues during the last two flights. On today's flight we discovered that another nadir port that is not in use on this campaign was also obscured by frozen jet fuel. Unlike the nadir 5 glass window for LVIS this window is an acrylic window and the shutter was closed at all times. We closed the shutter of the LVIS window and this reduced the frost a bit.

The jet fuel frost deteriorated the performance of the LVIS laser by roughly one order of magnitude, but due to a large performance margin the LVIS instrument was able to get surface returns along the cloud free segments of the arc and with better quality than on the November 4, 2010 flight.

**LVIS:** The LVIS system worked well. A frost layer on the outside of the window impacted the performance of the system by an order of magnitude, but LVIS acquired range data over the entire cloud free portion of the arch.

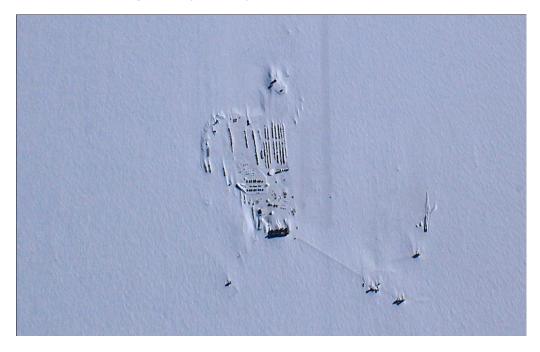
Figure 4: Amundsen-Scott South Pole Station as seen by the Digital Mapping System camera (DMS) on today's flight.

After we completed the arch at 90°E we did an overpass of the Amundsen-Scott South Pole Station, in order to best utilize the high-rate GPS data being collected there for our trajectory computations. We switched of all laser and radar science instruments 30 nautical miles before South Pole in order to avoid interference with any science experiments that are going on in the so called "dark sector" around South Pole Station. We flew over South Pole at 18:29 UTC and switched on the radars and lasers again after clearing the dark sector 26 nautical miles behind South Pole.
